SERVICE BULLETIN

Additional inspection to prevent a hub failure

All Hoffmann Propeller HO-V72 types that are/have been used for aerobatic.

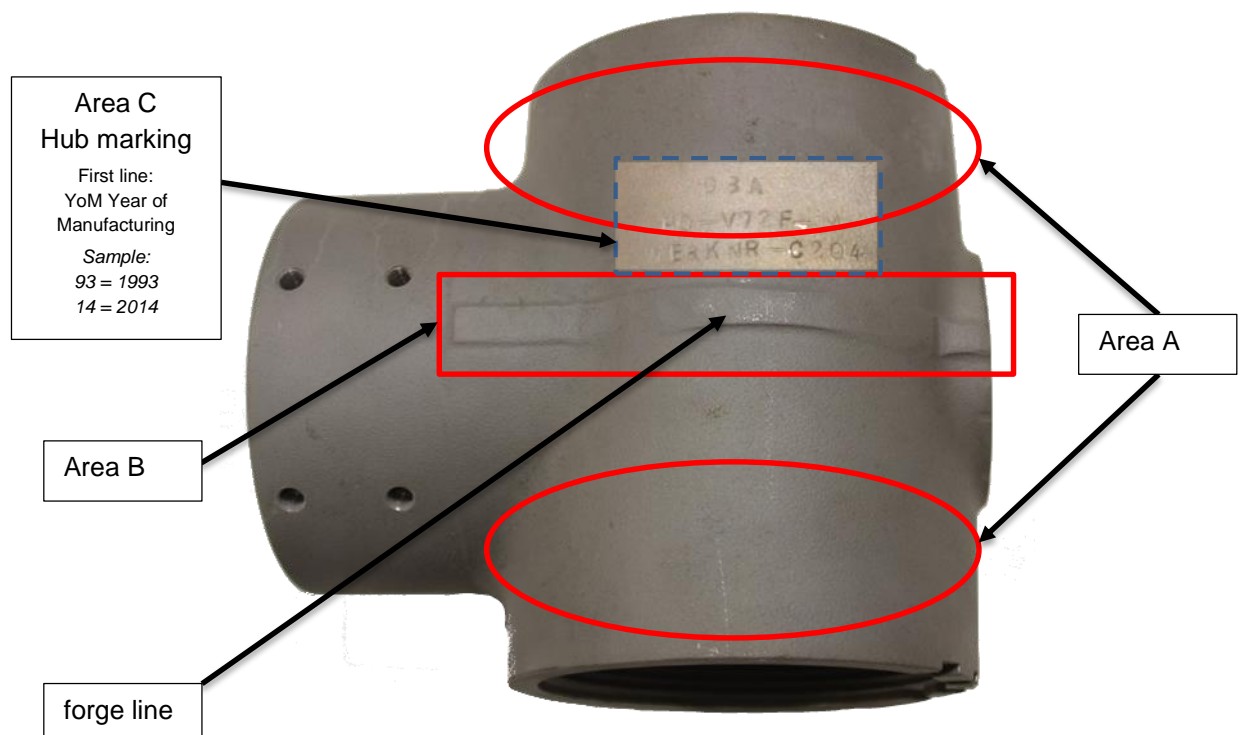
Figure 1: HO-V72() hub sample

Two hubs were found with cracks at different positions. Up to now, the cracks only occur on the application HO-V72L-V/V180CB installed on Slingsby T67 "Firefly".

- Remove the spinner dome.
- Visually inspect the hub for cracks. Especially inspect the blade sockets (area A, see figure 1). If you have a hub type with forge line (manly manufactured bevor 2005) inspect this area carefully (area B, see figure 1). If cracks were found the propeller must be send for investigation to Hoffmann Propeller further service of this propeller is not allowed.
- Reinstall spinner dome.

- The Propeller hub must be NDT inspected by an approved Service Station. The complete hub must be dye penetrant inspected. The threads in the hub sockets must be eddy current inspected. Detailed information on how to perform the NDT inspection can be found in Service Bulletin E25(). Hubs with cracks must be replaced. Report cracked hubs to OccurenceReporting@hoffmann-prop.com.
